Kakaci Well

Kakoc Well

La Camilla Well

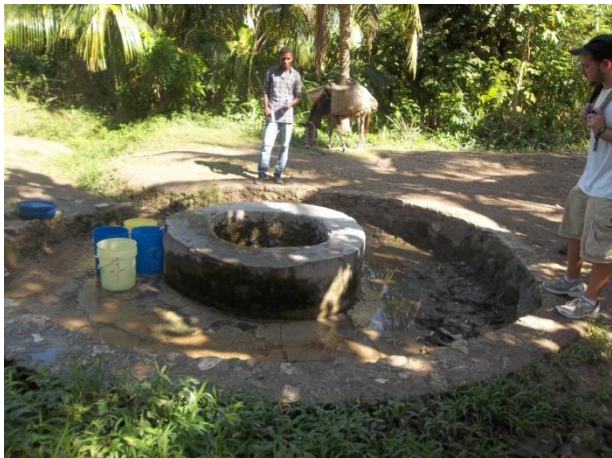
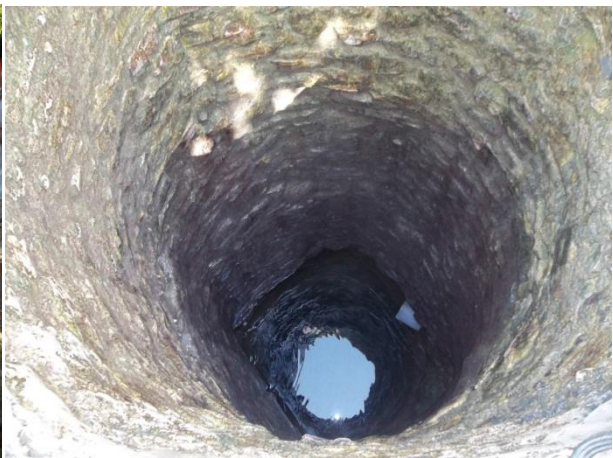
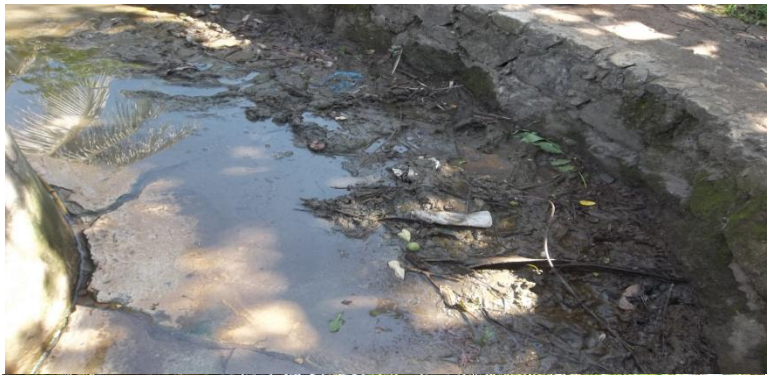
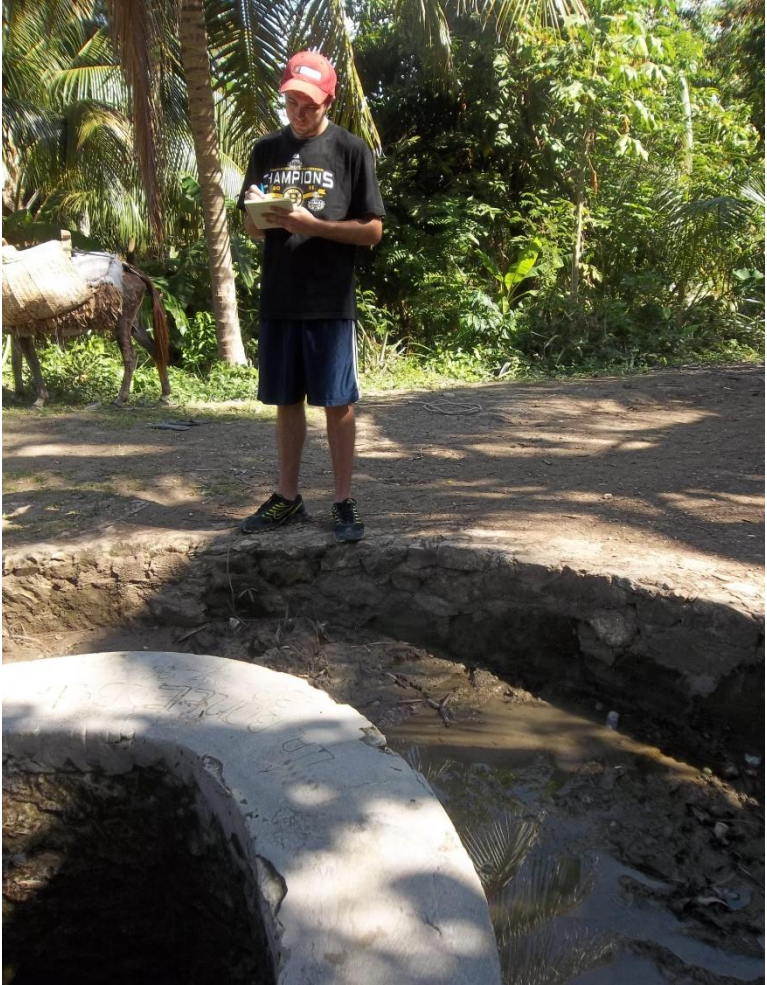
Surrounding Environment: The Kakaci Well is located in a more remote and shaded/woody area than what we have been used to seeing. It is located along a fairly narrow path that was a good mile away from any residences. There were no animals surrounding the area but there was some algal growth and debris on the cement base of the well.

PH	7
Salinity	0
Coliform	Positive
E. Coli	Positive

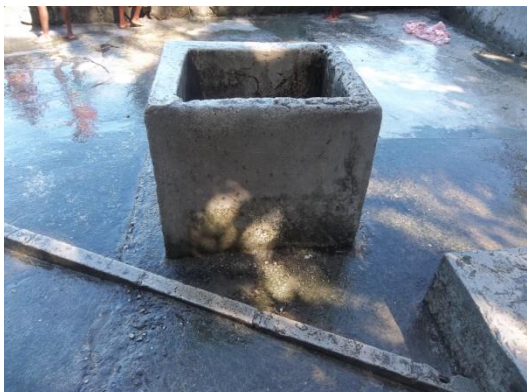
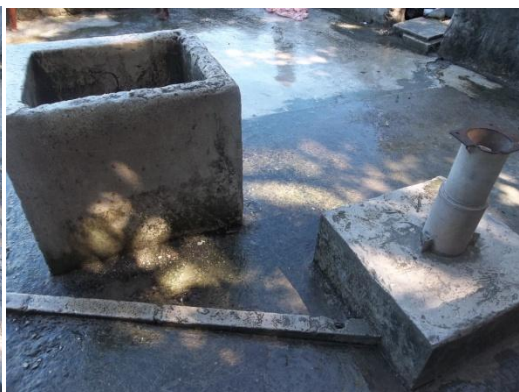
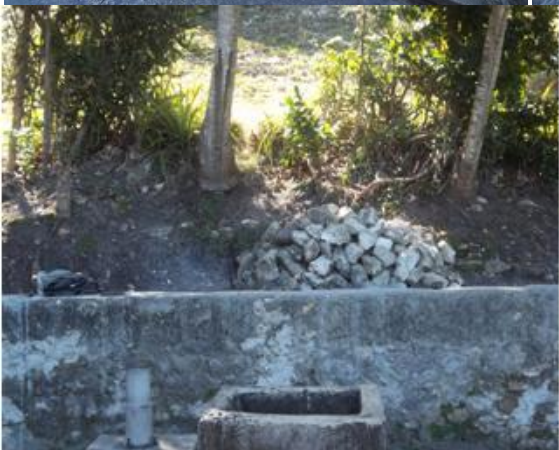
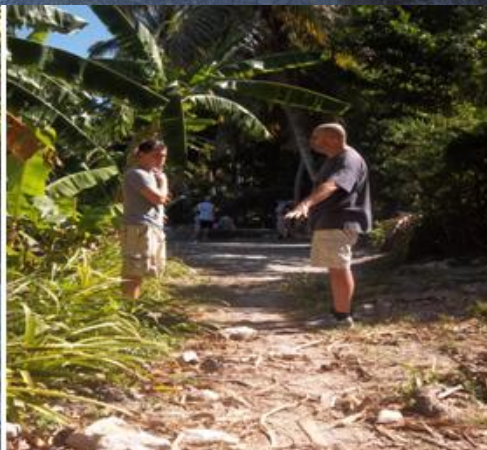
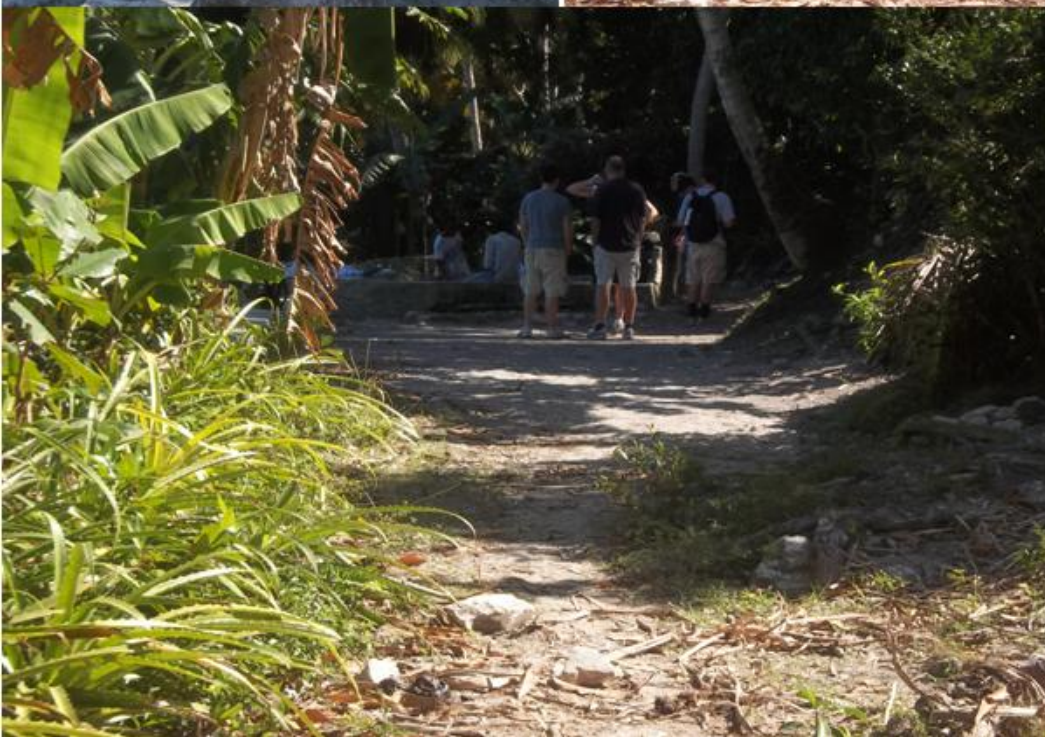
Brief History: Used to be a pump, but the pump has since broken. The local people then removed the pump and proceeded to pry the cement cover of the well off, leaving it exposed to contaminated buckets and local pathogens. When the pump was being used there was a bathing section off to the side where small cement pools would fill with well water, but the water filled too slowly for local use, which also helped to justify the local decision to remove the cover and use buckets instead.

Surrounding Environment: Surrounded by a steep vegetated incline and heavy vegetation around the fresh water fish farm. There is animal feces scattered around the grounds and used detergents being constantly dumped into the surrounding area. Plastic garbage can be found both inside and outside the cement structure. We found the cement structure to very slippery due to the amount of algal growth and the moist conditions.

Water Sample: A sample of water was taken at 0920 from a local woman's bucket that had just been lowered into the well by a nylon rope. We placed the water sample into the included "whirl-pack" bag that was provided in our water testing kit. We then proceeded to fill one test tube that will detect any Coliform in the water. Then using litmus paper we concluded that the waters PH level was 7.

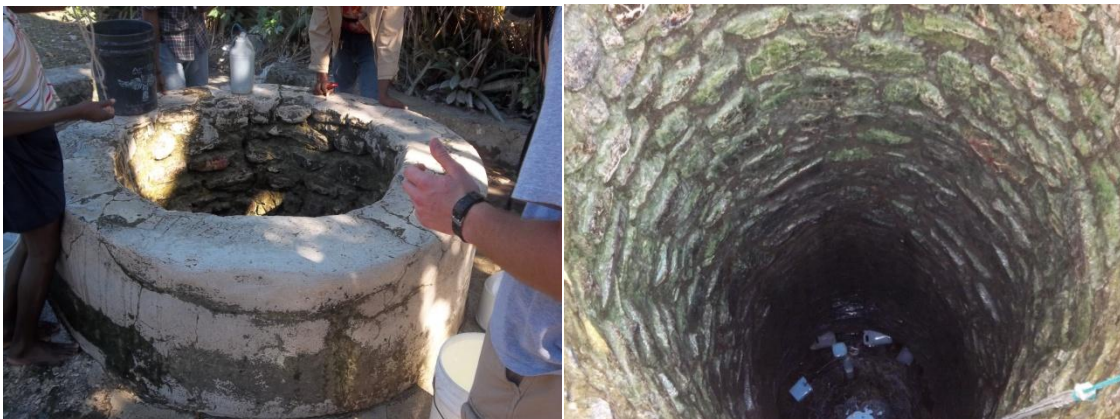
Troumillier Pump

Surrounding Environment: Open farmland on two of the surrounding sides with a muddy pathway that cut directly across. From one direction, there were some houses and pathways, on the other direction there was a school. While we were there we observed many animals including cows, horses, donkeys, etc. passing by and occasionally stopping for water while some grazed in nearby fields. There is a sloping muddy area caused by runoff erosion during their wet season. There was clear evidence of fecal matter and plastic garbage scattered around the area and uphill.

PH	7
Salinity	0
Coliform	Positive
E. Coli	Negative
